## **DISABILITY ACCESS AUDIT**

**Property:**  
Polling Stations

**Prepared upon the Instructions of:**  
Claire Felton  
Bromsgrove District Council

January 2007

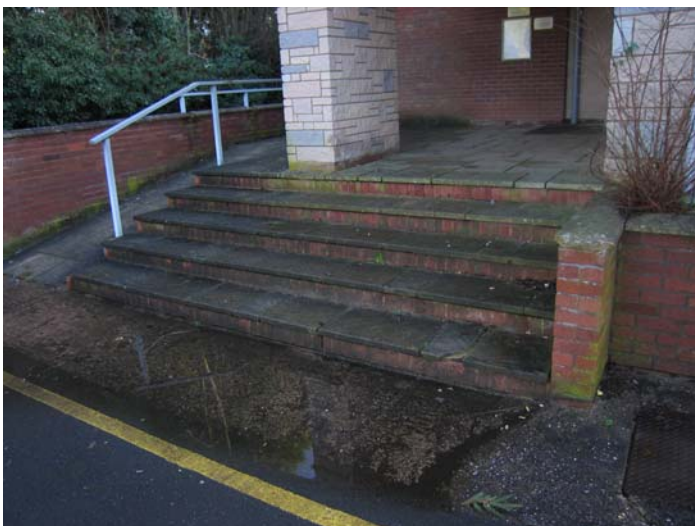
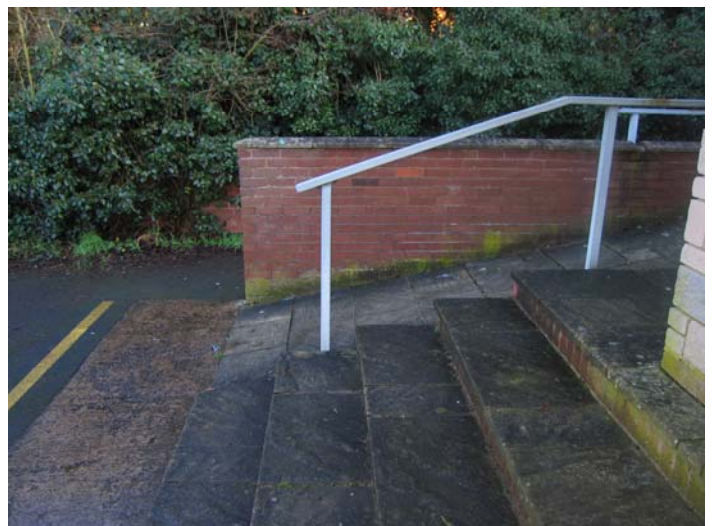
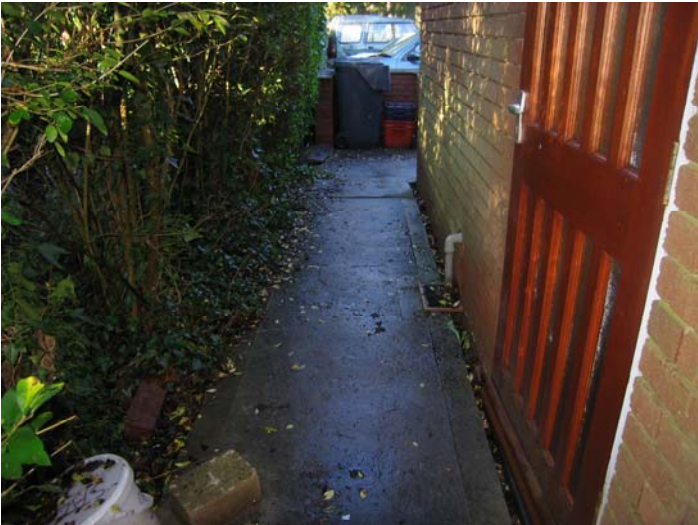
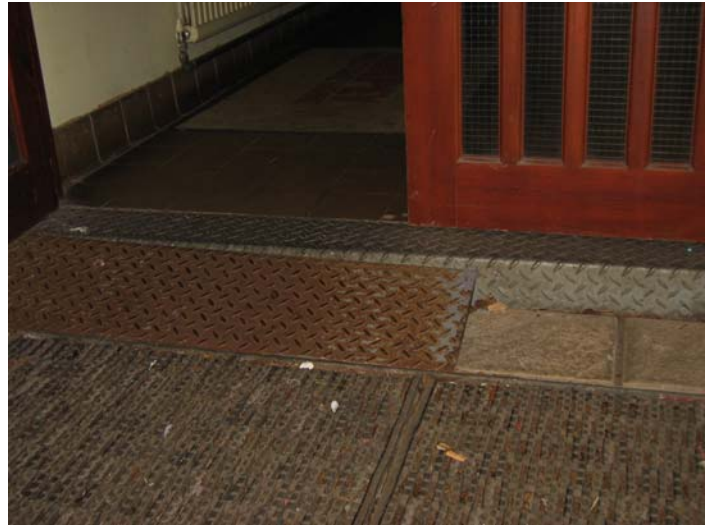
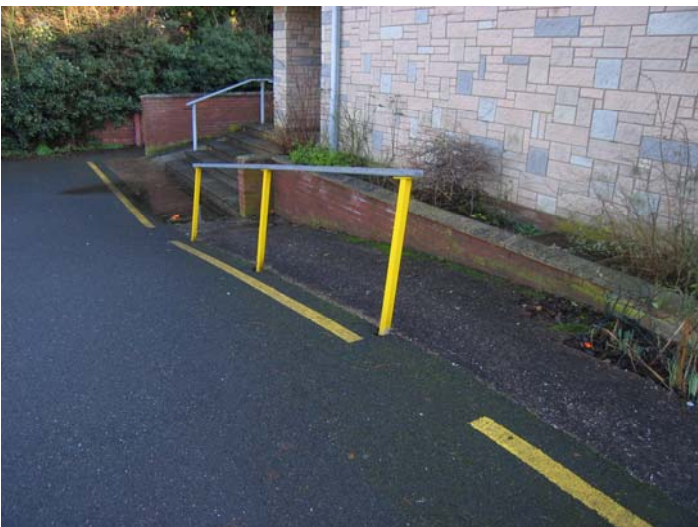
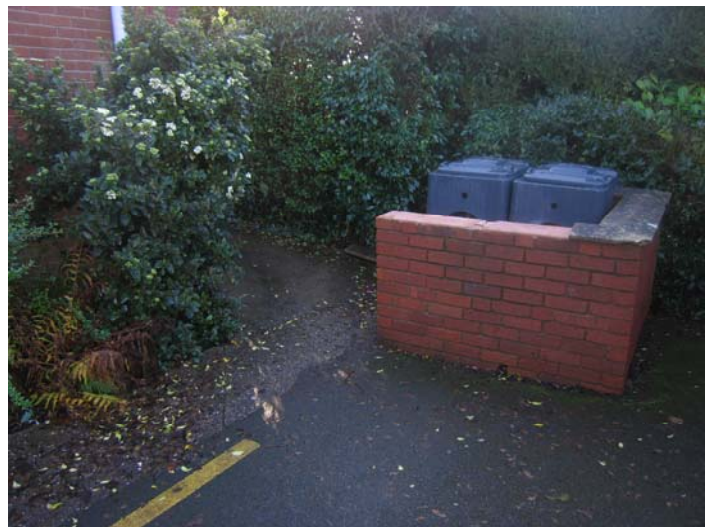
3.12 Dodford Village Hall, Priory Road, Dodford cont'd...

The steps to the front entrance provide uniform risers and treads, there is no colour contrasting slip resistant nosings to the steps. There is no tactile warning to the top and bottom of the flight to warn people of the steps and a hand rail has been provided to one side only that does not offer support for the full length of the flight. There are a number of broken treads and some are loose.

The ramp at the front has a gradient of 1:5.5. There is a real danger of people using chairs falling out of their chairs when descending or tipping backwards when going up. For a wheelchair user to use this unaided would require great strength and would suggest that there are few who can. The ramp provides a width of 1440mm (recommended 1500mm) and no handrail is provided as the adjoining one to the stairs will be out of reach to many users.

The route to the rear entrance is off the top parking area. I would suggest that this has not been intended to be used as a general access route. It provides a width of 950mm which is less than the recommended minimum of 1200mm in exceptional circumstances and has a slope within it at 1:9. Handrails are not provided. The route is obstructed by overgrowing vegetation.

This building at best has a number of issues that make in extremely difficult for some disabled people to access it and at worst is dangerous. The steps to the front which will be used by most people have loose and broken treads and the ramped access routes are steeper than the maximum recommended of 1:12. An alternative venue should be sought.

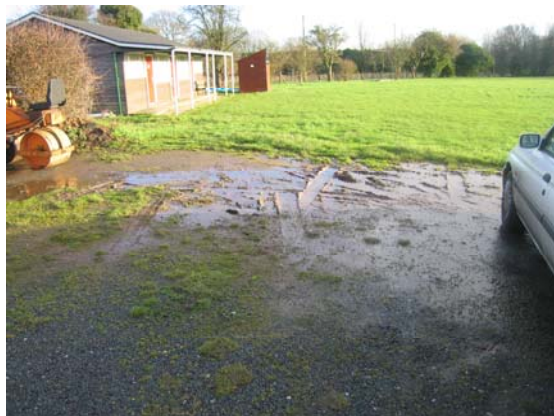
Parking at the ground is provided. Generally the area has a poor surface (tarmac) which is broken up with potholes. Parking bays are not marked out.

The route from the high way is along a drive way with potholes and an uneven surface, this also applies to the main parking area. There is an area that is level, firm and even but access is still via the drive. From the parking area to the pavilion is across a grassed area. Although this is predominately level the surface may not be firm or even, this may cause problems for wheelchair users or people using sticks etc.

The entrance doors are under a covered walkway which has a rise of 130mm above the grass. The doors have a threshold height of 200mm. The doors have glazing which allows good vision but provides a clear width of 530mm per leaf. The door furniture is a "D" handle that is higher than the recommended height.

This is not a suitable venue for a polling station due to the access routes. An alternative location should be found.

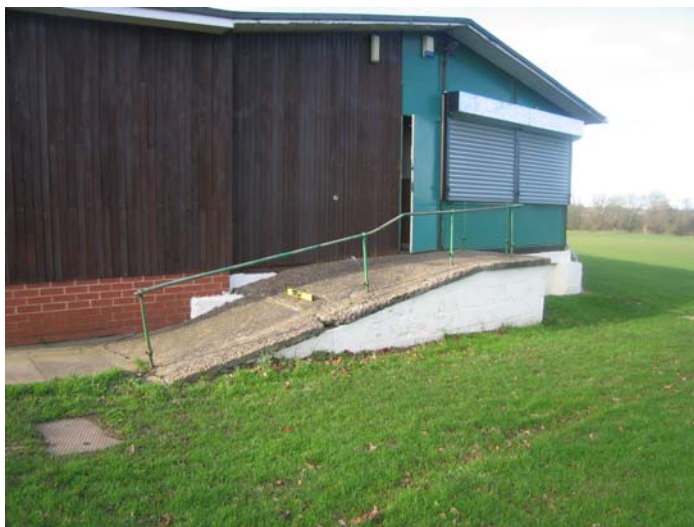
There are two main issues with this site, parking and the ramp to the alternative entrance. There has to be clear access in to the building which requires that the staff from the local business leave the entrance and access clear and the side ramp which I consider to be dangerous.

An alternative venue should be found.
