Arboricultural Implication Assessment

Preliminary Report on Trees

For:	Client:	Prudential Assurance	
	Agent:	Cunningham Lindsey (Wolverhampton)	
Site:	Homeowner:	Mr Butt	
	Address:	50 Lea Green Lane Wythall Birmingham W Midlands B47 6HN	
Refs:	OCA Ref:	37014	
	Client Ref:	12749024/01	
	Agent Ref:	2446379	
Survey:	Date:	15 th February 2007	
Report By:	Helen Sullivan		Date: 23 rd February 2007

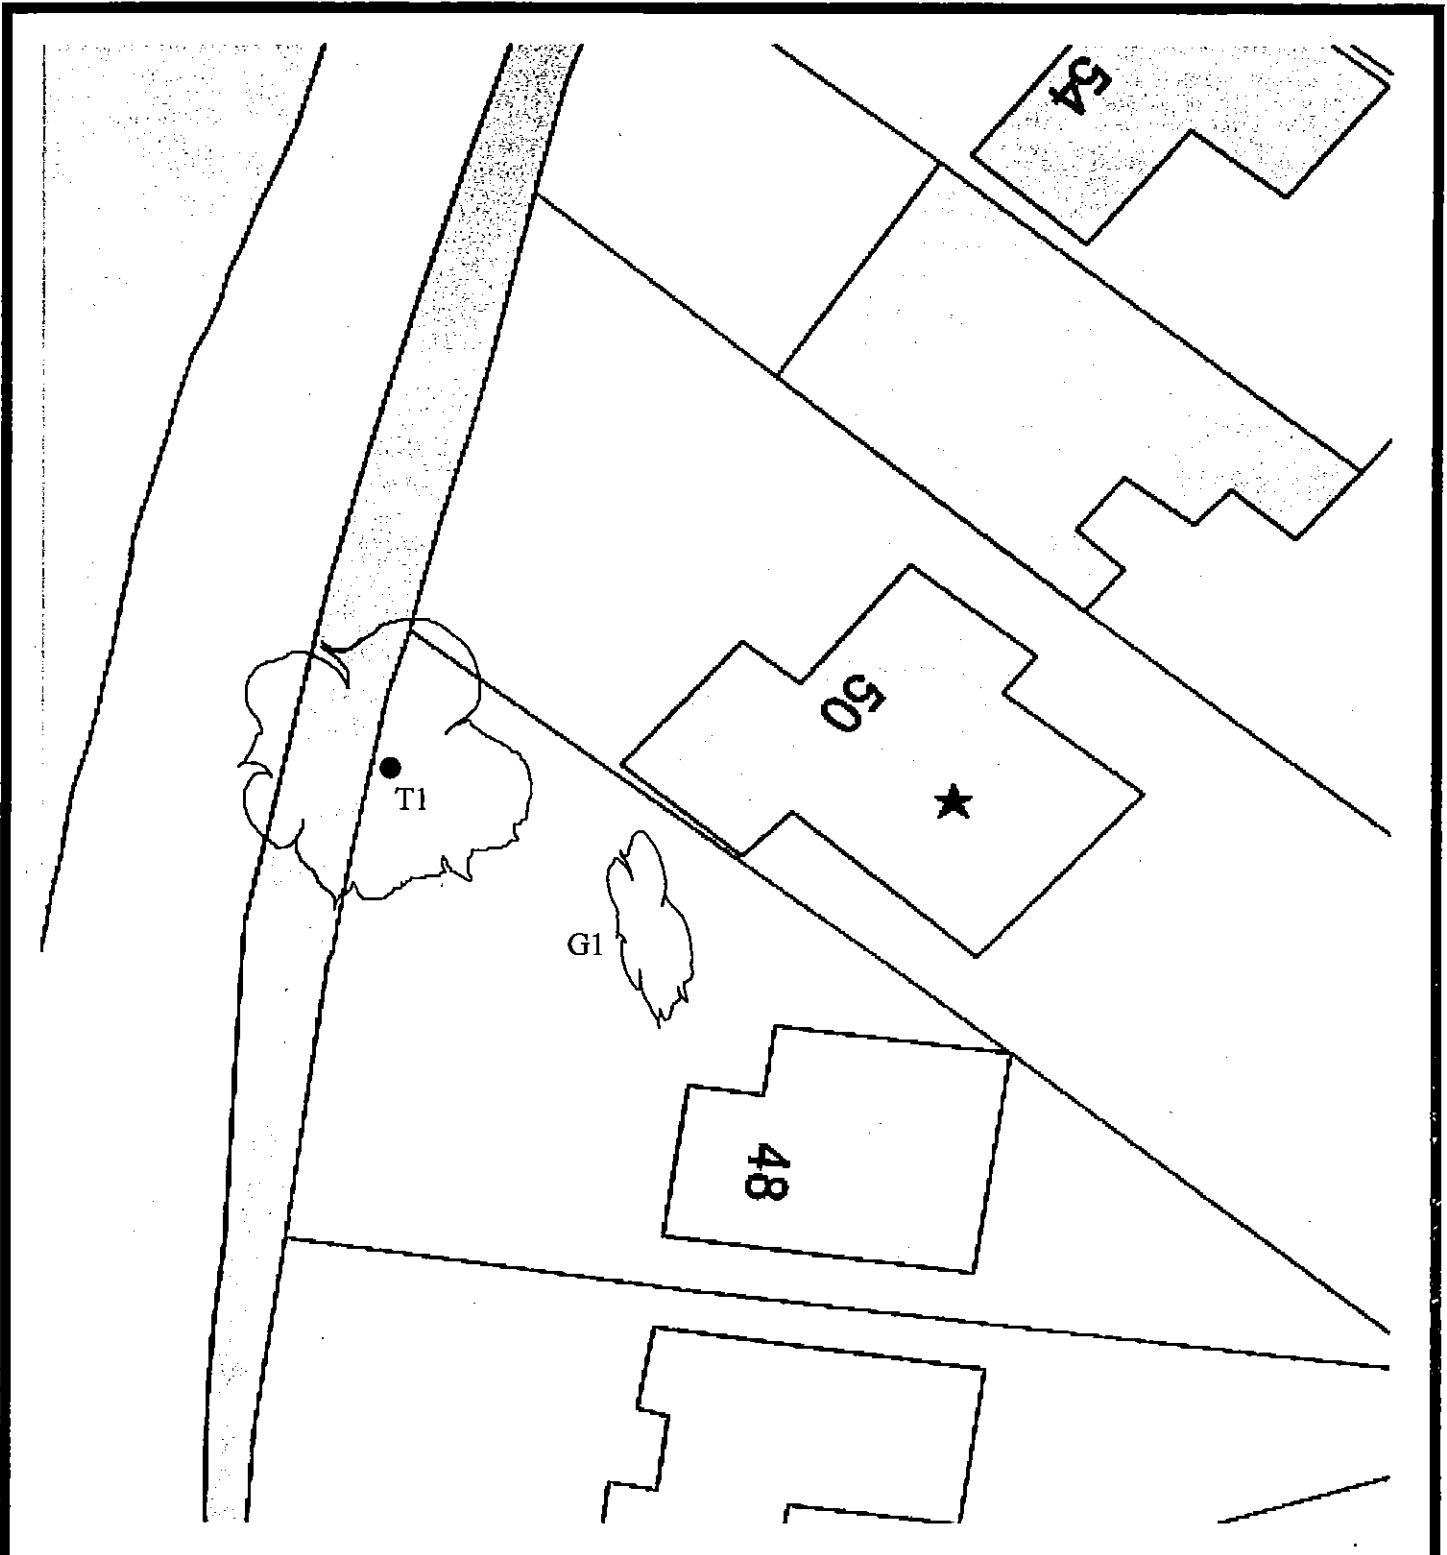
Roots emanating from *Quercus* (Oak) were identified underside of foundations. Taking into account all the available evidence and following our survey of the site it is our opinion that these roots emanate from the Oak tree (T1) as indicated on our plan.

Tree No.	Species	Age Class	Cond.	Height (m)	Crown Spread (m)	Diam. (mm)	Dist.to bldg (m)	Owner
G1	Cypress	EM	B	3.0	-	100	0.75	3P
Comments:

Tree No.	Species	Age Class	Cond.	Height (m)	Crown Spread (m)	Diam. (mm)	Dist.to bldg (m)	Owner
T1	Oak	EM	B	12.7	10.0	450	9.0	3P
Comments:

In this instance we consider that removal of the Oak tree (T1 and the group of Cypress trees G1) will be sufficient to mitigate in the current subsidence event.

No:	Species	Works Required	Ownership	*Est.Cost of Tree works
T1	Oak	Fell to ground level and treat stump to prevent re-growth	3P	£750.00
G1	Cypress	Fell to ground level	3P	£350.00
