# Appendix 4

**Tree Preservation Order (No 8) 2007**  
**Tree on land at 48 Lea Green Lane, Wythall, B47 6HW**

## **Statement in support of Proposal to Fell Tree**

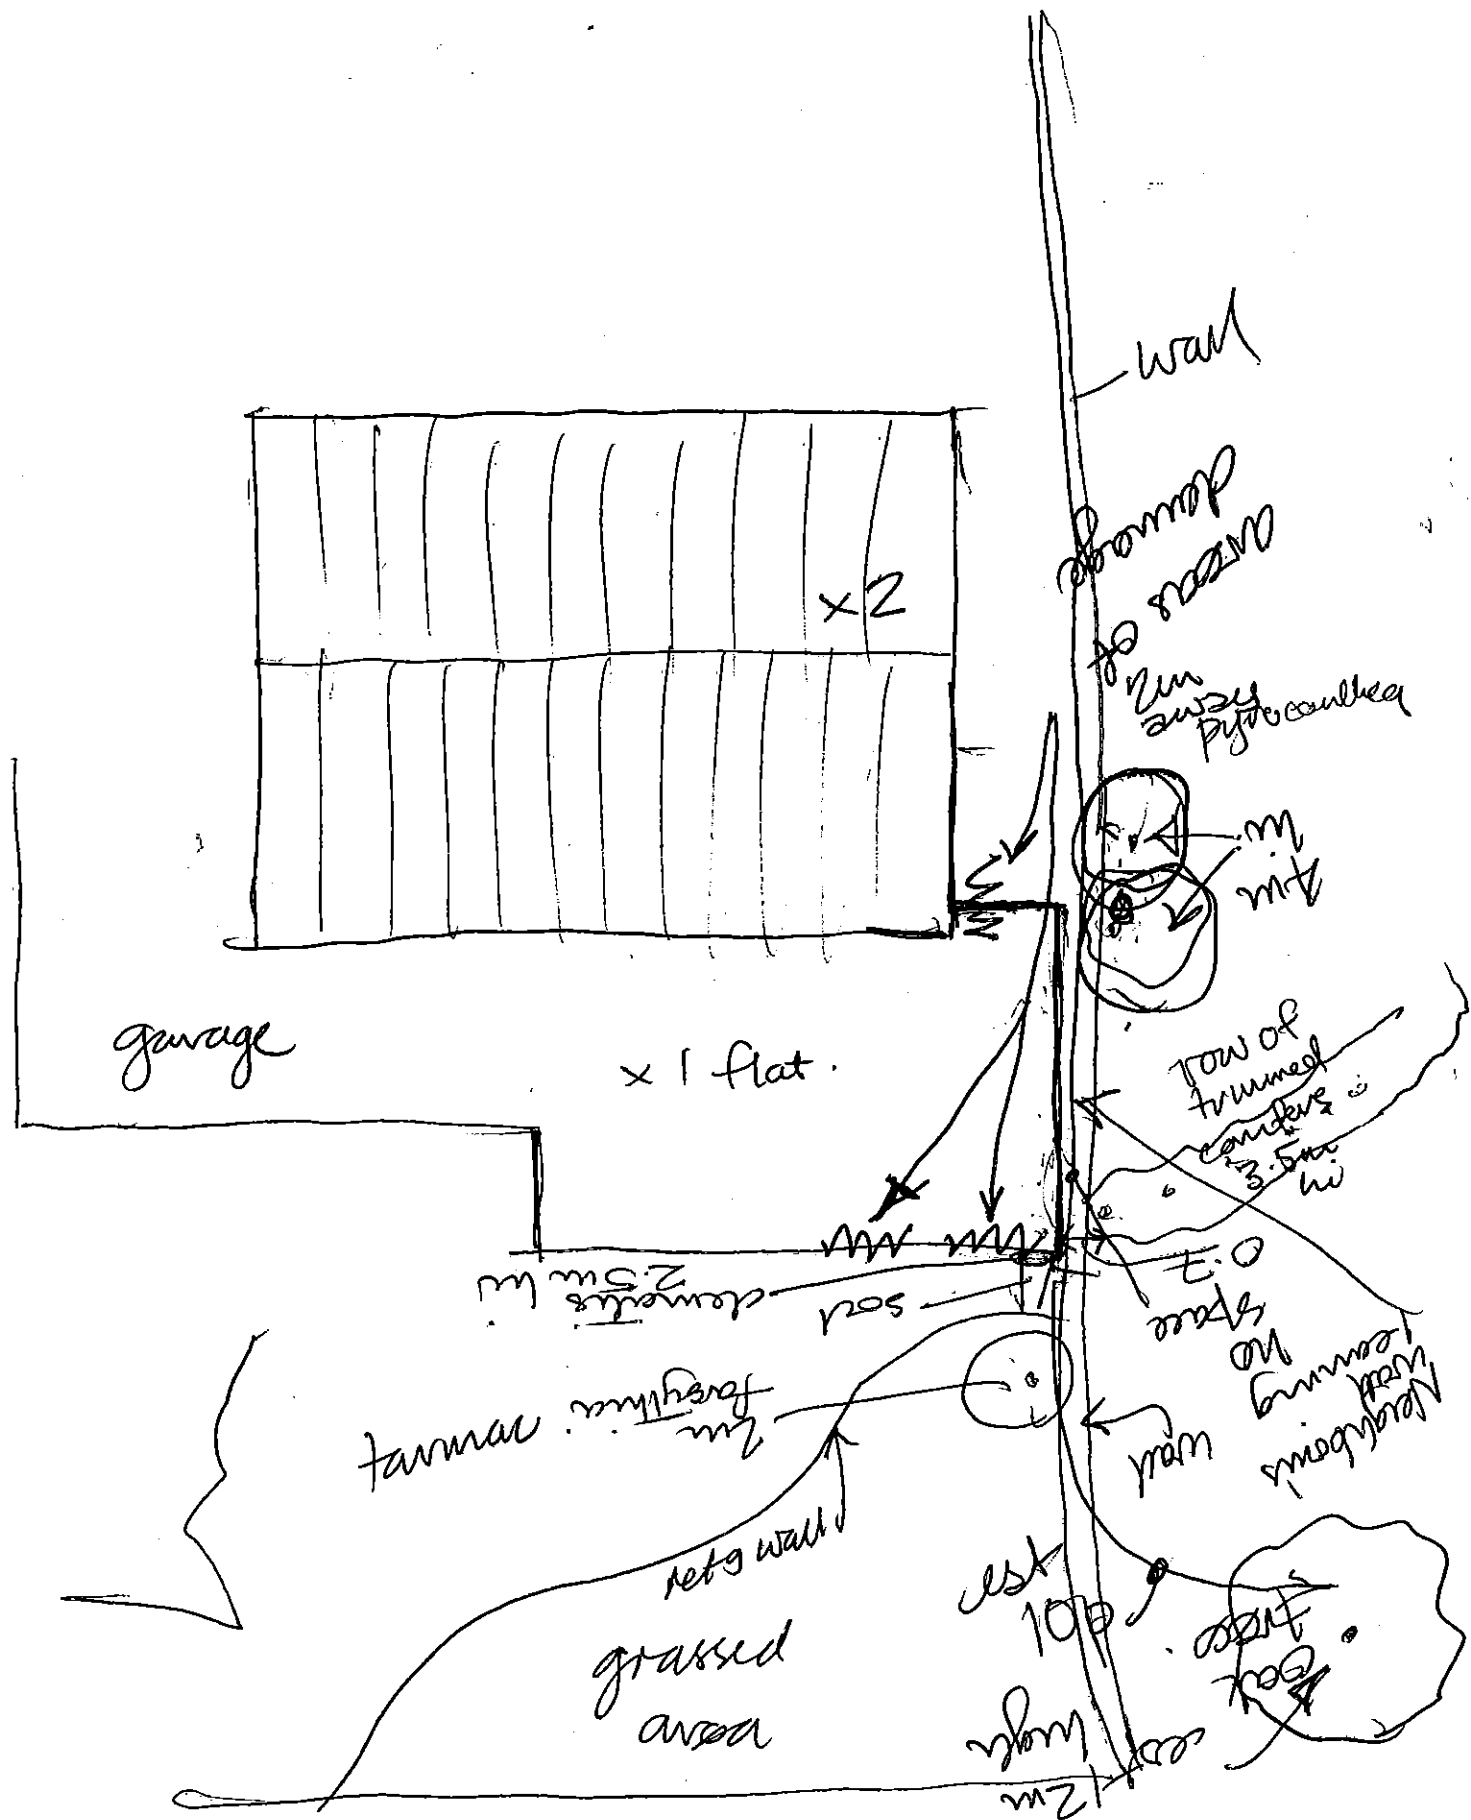
Site Plan

22/08/06

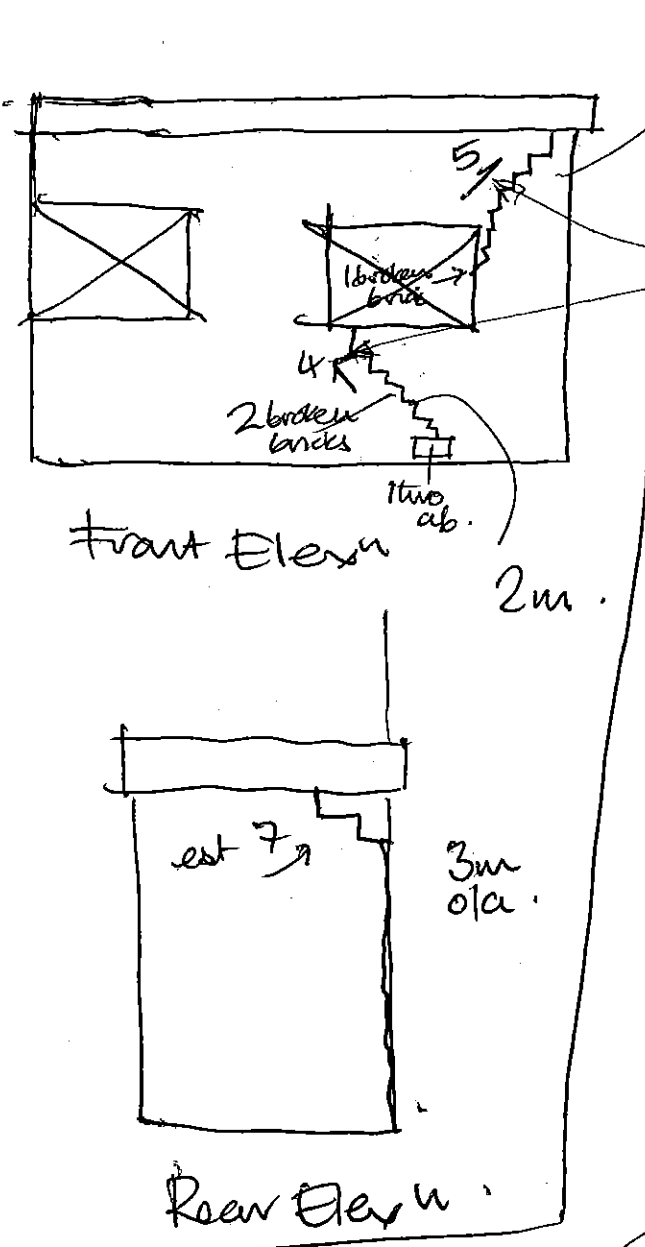
Front Elev'n

3m

crack widths  
22/08/06

External  
 att 1000  
 repair 1000  
 int 1000  
 repair 1000  
 decs 1000

4000-1000  
~~£~~ 3K

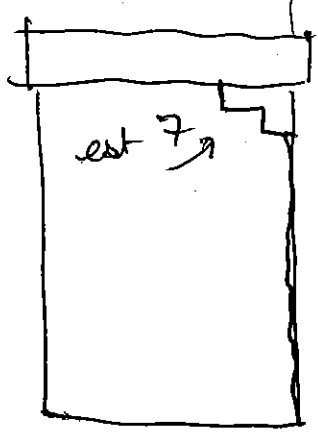
Rear Elev'n

3m  
1.2m

Crack widths  
22/08/06

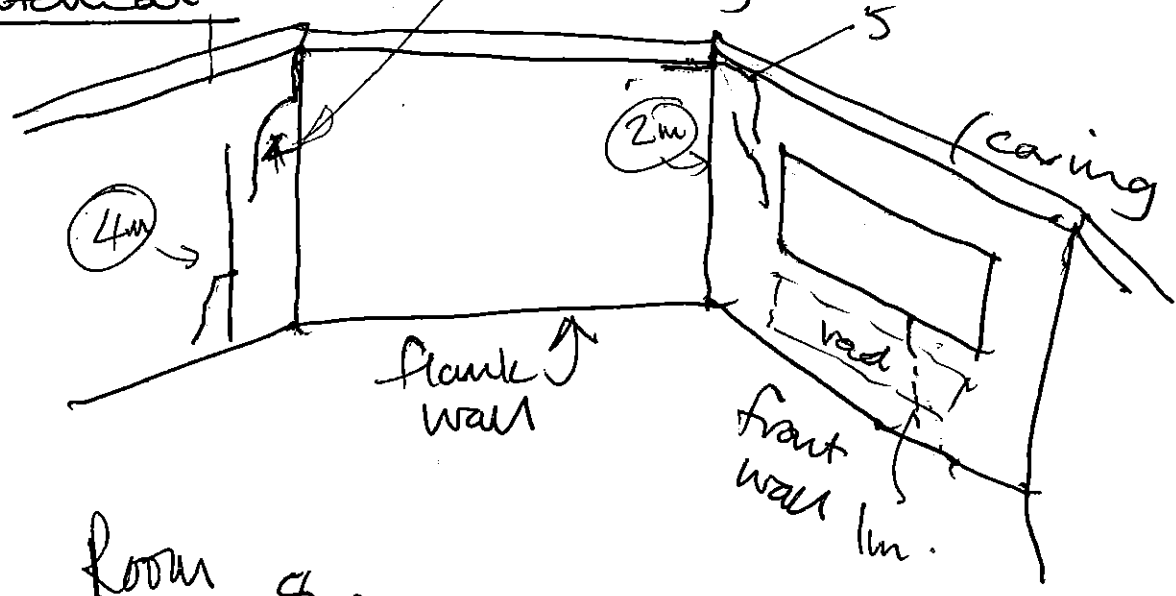
Internal

Ceiling OK

Room  
4 x 4.8  
x 2.4 high

papered / emulsion
