BROMSGROVE DISTRICT COUNCIL

MEETING OF THE ELECTORAL MATTERS COMMITTEE

Agenda Item 5

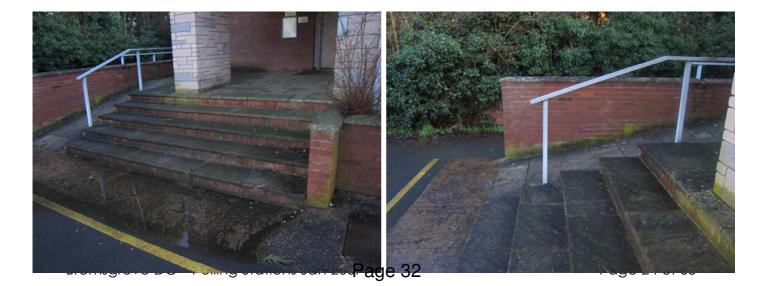
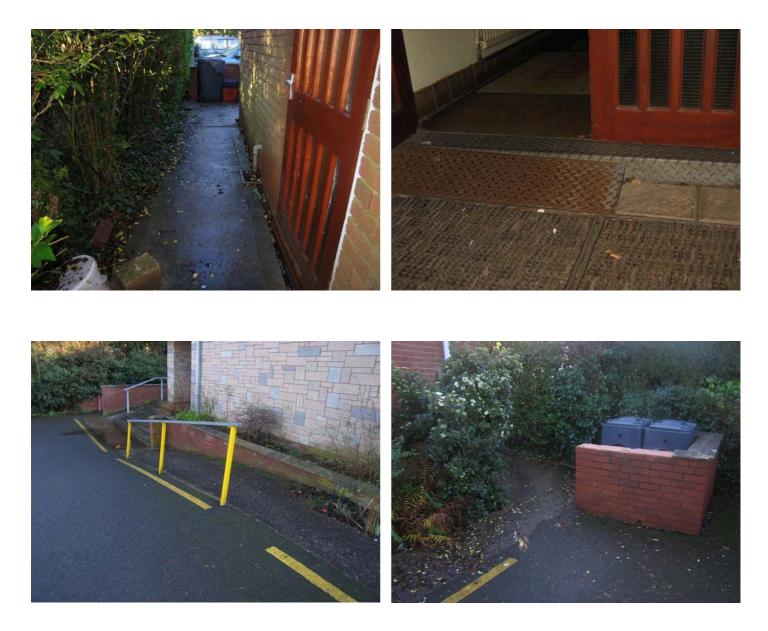
3.12 Dodford Village Hall, Priory Road, Dodford cont'd...

The steps to the front entrance provide uniform risers and treads, there is no colour contrasting slip resistant nosings to the steps. There is no tactile warning to the top and bottom of the flight to warn people of the steps and a hand rail has been provided to one side only that does not offer support for the full length of the flight. There are a number of broken treads and some are loose.

The ramp at the front has a gradient of 1:5.5. There is a real danger of people using chairs falling out of their chairs when descending or tipping backwards when going up. For a wheelchair user to use this unaided would require great strength and would suggest that there are few who can. The ramp provides a width of 1440mm (recommended 1500mm) and no handrail is provided as the adjoining one to the stairs will be out of reach to many users.

The route to the rear entrance is off the top parking area. I would suggest that this has not been intended to be used as a general access route. It provides a width of 950mm which is less than the recommended minimum of 1200mm in exceptional circumstances and has a slope within it at 1:9. Handrails are not provided. The route is obstructed by overgrowing vegetation.

Comments

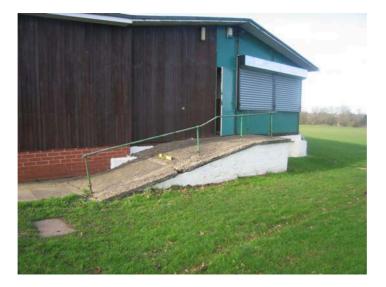
There are two main issues with this site, parking and the ramp to the alternative entrance. There has to be clear access in to the building which requires that the staff from the local business leave the entrance and access clear and the side ramp which I consider to be dangerous.

An alternative venue should be found.
