P0829 Bird Box, Bromsgrove

Landscape Masterplan Medium cost option

DRAWING NUMBER BBX-ONE-ZZ-XX-SK-L-0001

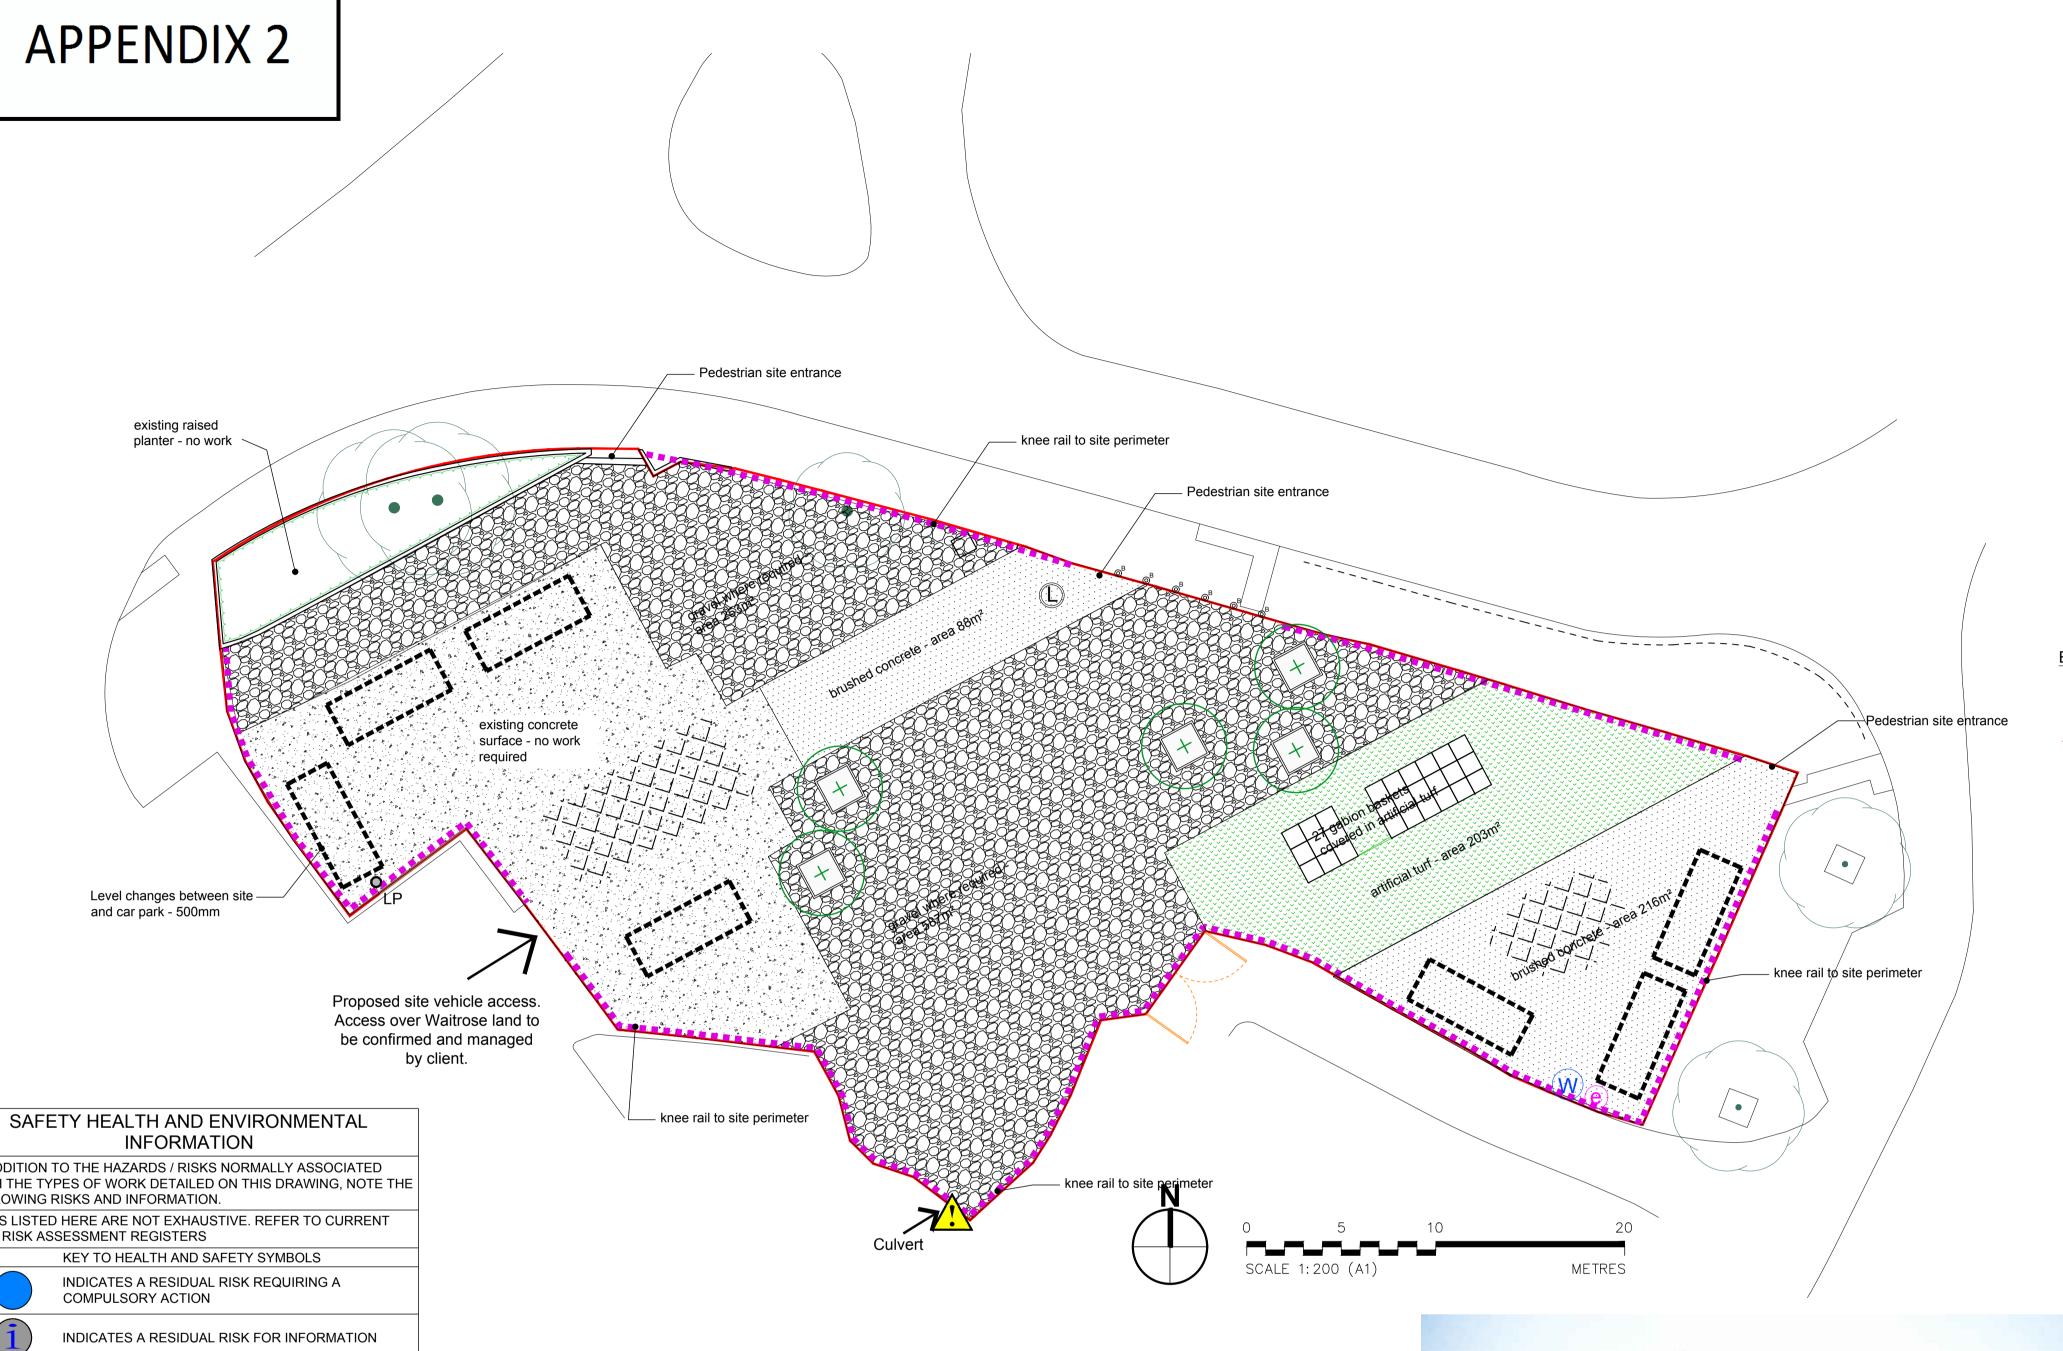
Soft Landscape

Retain existing trees

Proposed feature trees in moveable planters Total number: 5

Concrete surface retained Refer to drawing BBX-ONE-ZZ-XX-DR-L-0010 Paving and Edging Plan. Total area: 323m²

Proposed artificial turf with flush timber edging

Proposed concrete with brushed finish

remove 100mm depth of unsuitable existing surface and replace with gravel.

Timber knee high fence to surround

Existing bollards retained

Proposed Turf Seating Cubes

Varying heights of gabion basket covered in artificial turf as seating. Refer to drawing

Secure/ lockable electric point with 2no. sockets Total number: 2

Proposed lockable bib tap Total number: 1

Existing Lamp Post to be retained Refer to BBX-ONE-ZZ-XX-DR-L-0005 Lighting Strategy

Temporary paving graphics Feather design - scope tbc

Potential location for temporary containers

Remove 100mm depth of unsuitable existing surface

where necessary provide a double kerb restraint where there is a difference in level to the public footpath.
