# BROMSGROVE DISTRICT COUNCIL MEETING OF THE OVERVIEW AND SCRUTINY BOARD

### **SUPPLEMENTARY PAPERS 2 DOCUMENTATION**

4. Land Drainage Watercourse Maintenance Operation - pre-scrutiny (Pages 1 - 10)

# Bromsgrove District Council Watercourse Maintenance Schedule

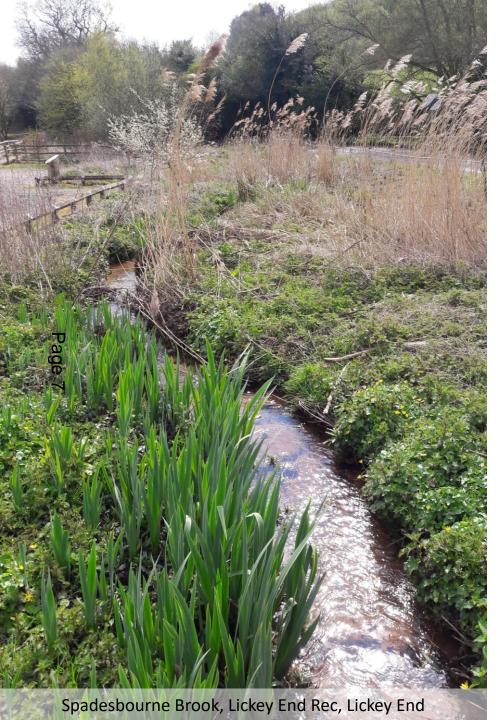
### Case Study: Lickey End Recreation Ground

- In January 2019 NWWM became aware that excess silt & vegetation in the Spadesbourne Brook was impeding the flow of water, leading to flooding of the adjacent highway.

- In August 2020 NWWM organised for an ecologist to survey the brook for water voles and found they were present on site and a contractor was appointed to undertake the necessary maintenance work in accordance with the ecologist's recommendations.

- In October 2020, before the ecologist's formal report had been received, an operative in the parks team carried out clearance work along the brook, and while it was done with good intentions it did not follow the best-practice guidelines.

- A follow up visit from the ecologist was required, and an external contractor was then appointed to undertake sympathetic maintenance work to restore the flow of water and mitigate the earlier damage done, in December 2020.

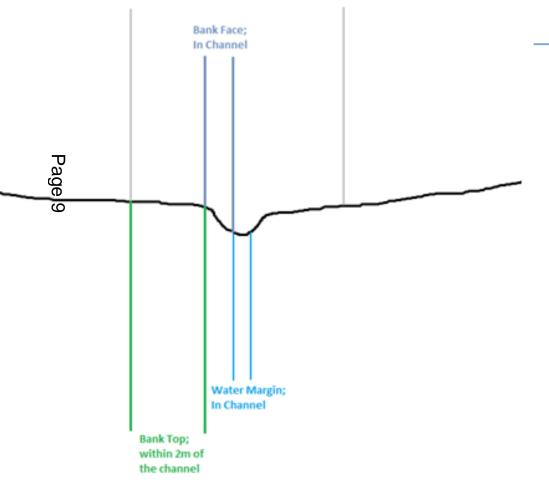
### riparian zone which impacts or is impacted by the watercourse
