**A REPORT INTO SECURITY  
AT  
CHURCHFIELDS  
MULTI STOREY CAR PARK  
BROMSGROVE**

**PETER ASTON  
CRIME PREVENTION DESIGN ADVISOR  
WEST MERCIA POLICE**

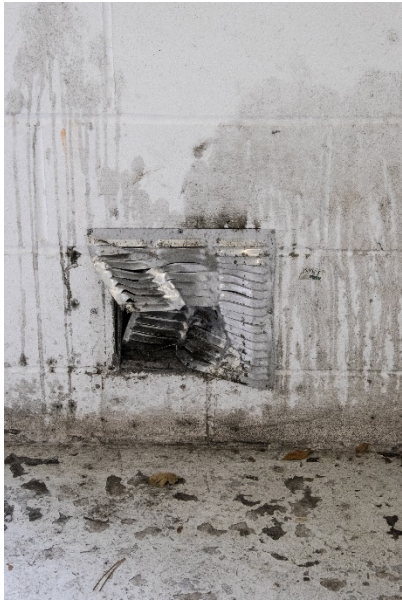
The condition of the main stairwell is very poor as the following photographs show the level of graffiti has increased, the walls are dirty and stained and the floor is also dirty. Litter is strewn across the floor, the access doors to the various floors are in poor condition and some of them have window glass missing. The overall impression now is of a poorly maintained and rapidly deteriorating car park, which would certainly not achieve the Safer Parking award.

**Top left:** Every air vent has been kicked in.

*Action 1. All of the walls to the stairwells need repainting with a bright reflective paint, preferably one that graffiti can be easily removed from. In addition the floors need cleaning so that they are also brighter.*

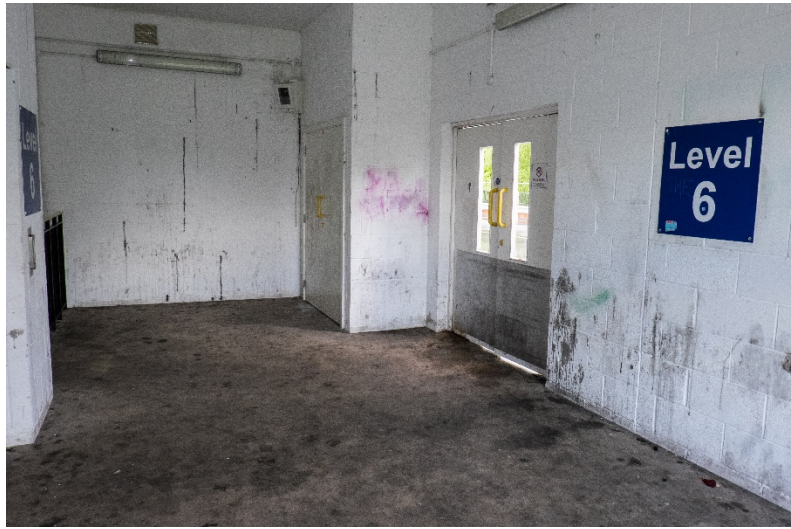
**Top right:** Stairwells are dirty and poorly maintained

*Action 2. All doors giving access to the stairwells should be repaired and repainted.*

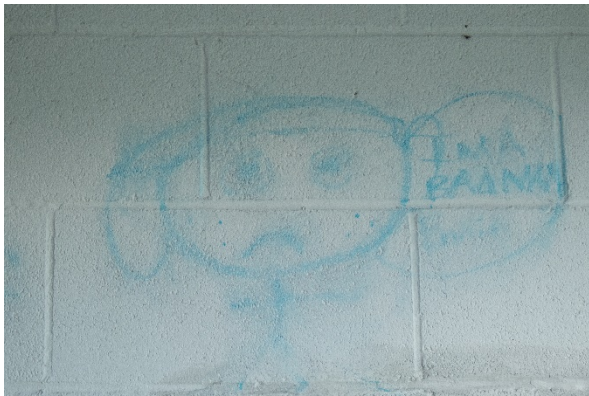
**Second Row:** Photographs showing some of the graffiti that has appeared on the walls.

Youths are gaining access to the car park mainly when it is closed and using the top floor to engage in anti-social behaviour. This behaviour has resulted in damage being caused including the broken windows in the doors and graffiti on the walls. In one incident a shopping trolley 'parking' area was badly damaged.

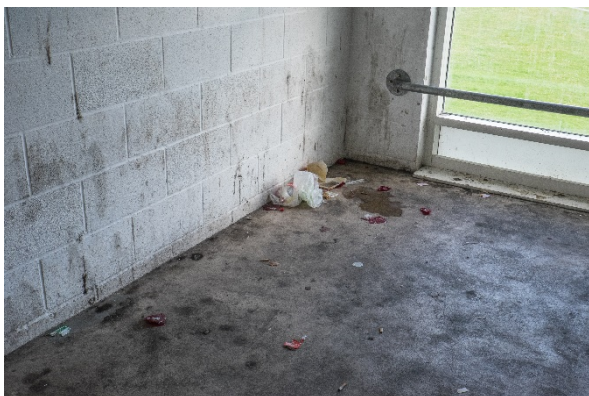
**Below:** Litter is left in the stairwells adding to the general impression that this car park has

*Action 3. A regime needs to be introduced whereby any litter is quickly cleaned up.*

*Action 4. A check of the stairwells every morning by car park staff would be useful and then reporting any litter graffiti or damage to the appropriate department of the local authority. In turn that department should respond quickly to such reports.*

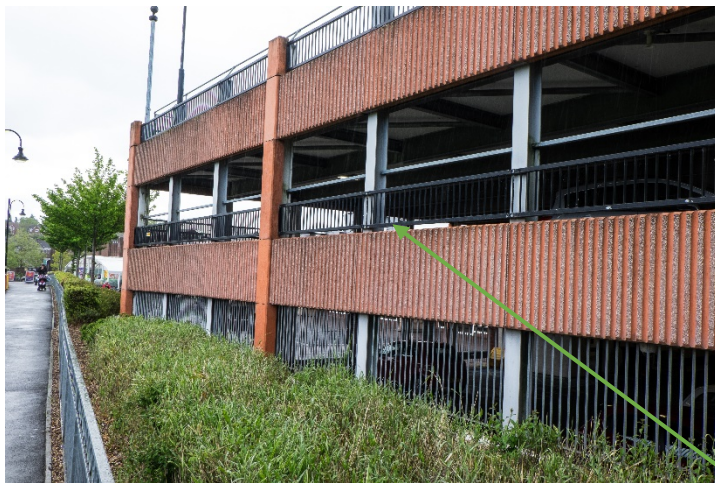
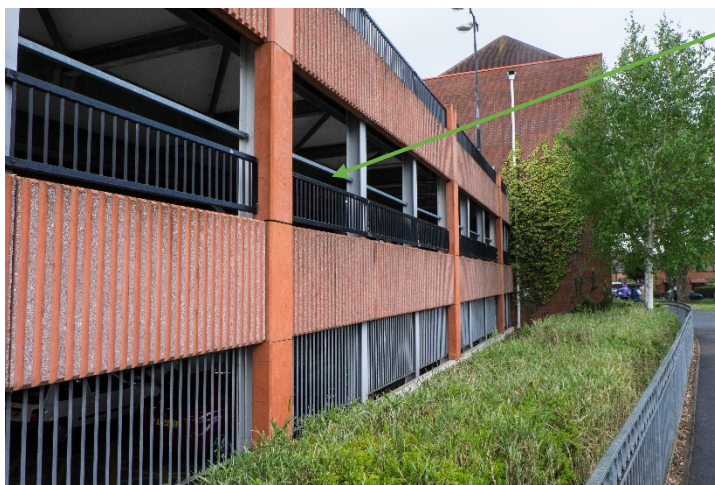
Access is being gained to the car park by climbing up the outside of the building onto level two. They are then opening the level 2 fire door on the opposite side of the car park to let their friends in.

Youths are gaining access to the second floor by climbing up the outside of the building.

*Action: Install fencing to the same specification as that on the ground floor along the side of level two this will remove any opportunity for access onto the car park from this location.*

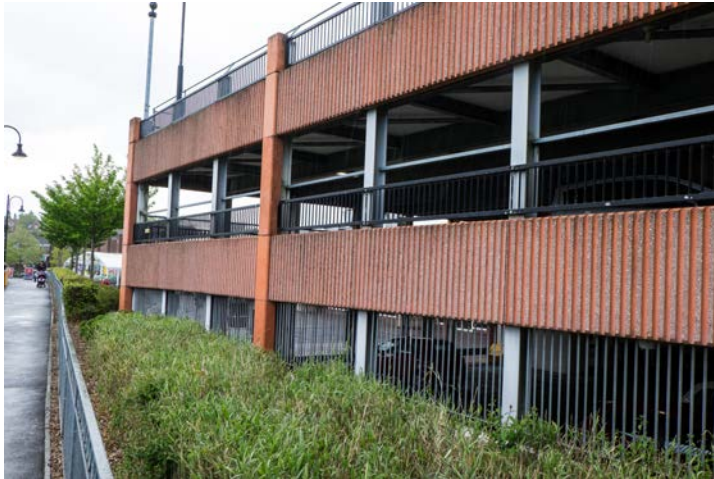
In order to prevent unauthorised people getting onto the car park when it is closed any potential access point needs to be removed. It has been identified that youths are gaining access to the second floor from the footpath that runs parallel to the car park (see photographs below)

Note the railings on the ground floor. Similar railings should be put along this edge of the second floor to prevent access.
